Research Article

# Analyzing capacity of a consumer-grade infrared camera in South Africa for cost-effective aerial inspection of building envelopes

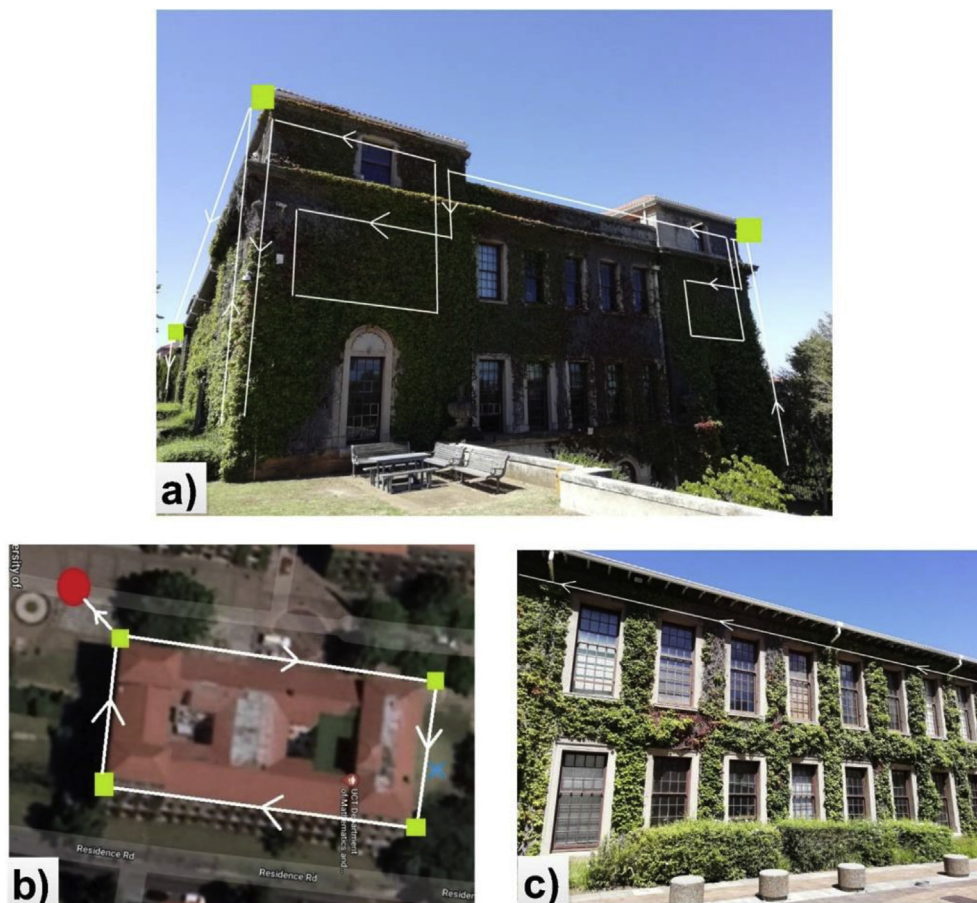
**Fig. 2** Images of Building 1, with sample portions of the UAV flight path marked by white lines. (a) Flight paths on a façade. (b) Flight path around the building marked on an aerial view (©Google Maps). The red dot represents one of the staging points on the ground. The blue cross represents a secondary landing site that was kept ready in case of unplanned landing. (c) Flight path along a roof-wall edge.

The drone was fully charged following the manufacturer's protocol, and the survey flight paths were run (Fig. 2). A successful operation meant that we could utilize the onboard microcontroller to trigger an image capture from the IR camera. A pause of 5 s was used for the points in flight, and the images were to be captured to account for the time that lapsed for capturing an image. The survey was completed in 16 min and 58 s, with over two charges of the battery. The original time planning was 14 min for imaging, 2 min and 39 s for flight, and 30 s as buffer.

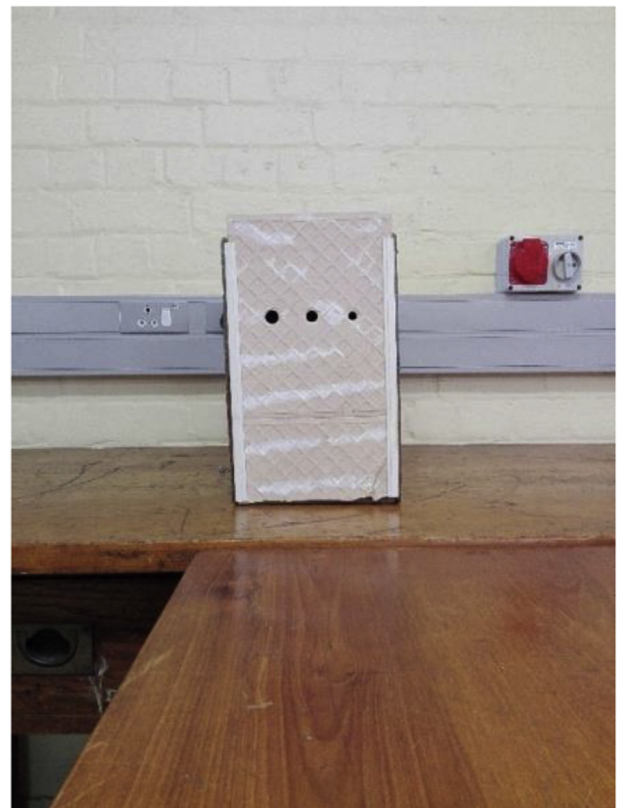
Fig. 5 Optical image of a tile with 16, 14, and 10 mm-diameter holes as an example of the setup.

In ideal scenarios, an IR inspection system should be able to detect even the smallest leakage. Here, six 5 mm-thick holes were drilled into two glazed ceramic tiles at three holes for each tile (see Fig. 5). These holes ranged in the diameters of 3, 5, and 8 mm for Tile 1 and 10, 14, and 16 mm for Tile 2. The smallest hole diameter was chosen on the basis of the smallest drill bit available. A tungsten lightbulb was placed inside a box and used as the heat source. The sides of the box were sealed with silicone to be able to maximize the heat exiting through the holes.
